Meet David

Matrx® Libra and MX2 Case Study

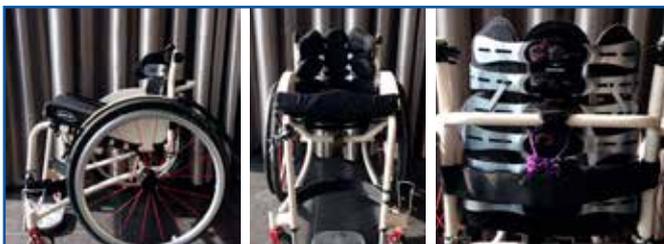
Figure 1 - Current products used by David

David owns a privately purchased Oracing manual, custom-made wheelchair, which has an ergoseat. He currently uses an Invacare Flotech Image cushion, combined with a back support, both of which he was given to trial.

He states that he likes the cushion, however, he indicates it's the wrong size for his wheelchair as it's a loan cushion and that it feels hard, lacks shock absorbency and has started to sag, not giving him the postural stability he needs. He also advises that

the fluid has a tendency to flow over the rear edge of the cushion, leaving him with nothing under his buttock where he's prone to skin breakdown.

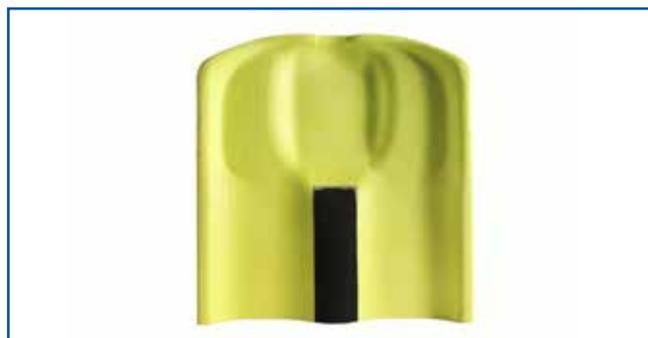
Figure 2 - Matrx Libra special design features

After discussing David's needs and explaining the design features of the Matrx Libra, both parties agreed that the Libra would likely be a good solution, given its positioning and skin protection qualities. The shape and contour of the Libra would keep the fluid in place, especially due to the rear cushion radius.

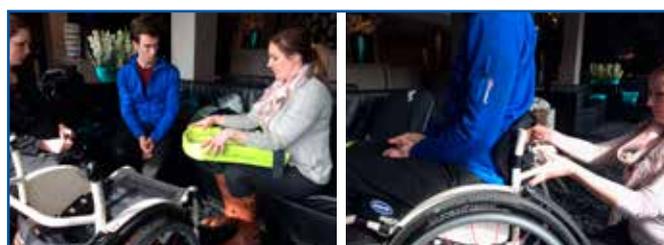
Figure 3 - Matrx Libra review and Matrx MX2 backrest fit

David was also keen to try the MX2 back support that Rhona had brought along. This would offer David more flexibility owing to the carbon fibre layers, as well as more suspension and shock absorbency, all of which he seems to be missing from his current back support.

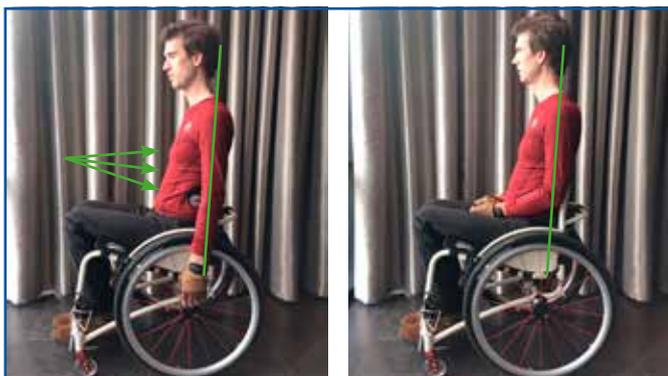
Figure 4 - David's posture comparison between seating systems (lateral view); right picture shows a combination of Matrix Libra cushion with Matrix MX2 backrest.

In Figure 4, it is possible to see a major improvement on David's posture, by using the combination of the Matrix Libra cushion and Matrix MX2 back (picture on the right). David sits more upright - no more wrinkles on the shirt - and shows better head positioning - head over shoulders, over pelvis. This was accomplished because we were able to reduce the abnormal thoracic kyphosis.

In a bid to correct David's shoulder alignment a fluid sac was placed onto the left trochanteric shelf of the Libra, however, David didn't tolerate this well, so it was removed. Also in Figure 4, left side, we observe that David's hips abduct slightly, likely as a result of his height causing his lower leg position to be just off midline. David agrees he has the feeling he wants to bring his legs closer together. A few tests were undertaken in order to make David feel more comfortable.

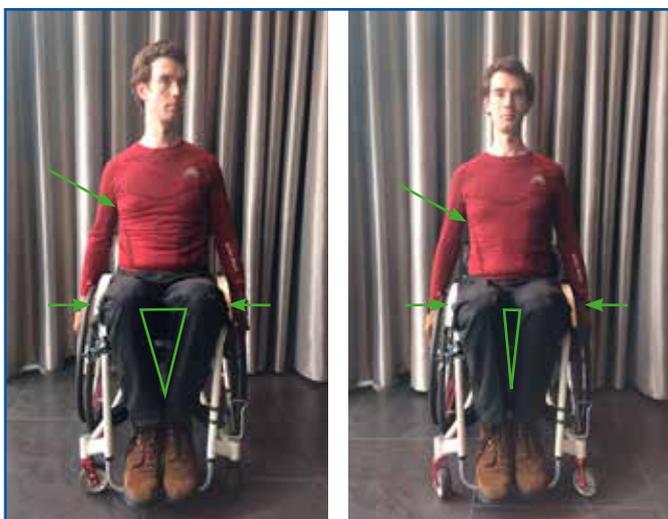
Figure 5 - David's posture comparison between seating systems (front view); right picture shows a combination of Matrix Libra cushion with Matrix MX2 backrest.

Using the same reference points, Figure 5, right picture, shows an interesting improvement in trunk extension - no evidence of postural collapse. This means a positive impact in the physiological functions, as well as reducing the intervertebral disc pressure. Despite the improvement, it is still noticeable that his right shoulder appears lower than his left.

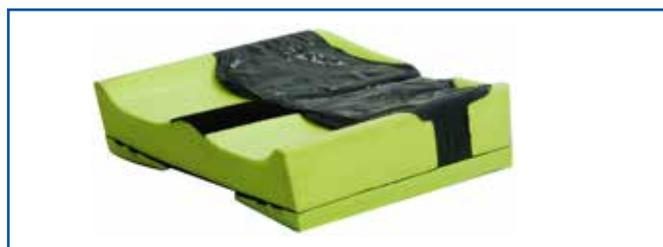
Figure 6 - Matrix Libra cushion with side wedges

Firstly, lateral wedges were placed under the base of the Matrix Libra cushion as seen in Figure 6. However, this proved too aggressive for David's needs.

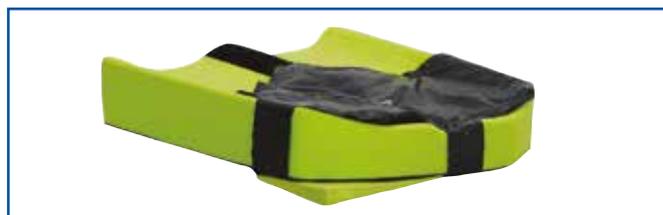
Figure 7 - Matrix Libra with tapered wedges

Secondly, smaller tapered wedges were placed at the rear of the cushion (Figure 7), but again, David felt this input was also too aggressive.

Finally, the decision was to cut the tapered wedges to approximately half their existing size. Being smaller, the positioning input was smoother and when sitting back on the cushion, David immediately reported an improvement in both his comfort and position. His leg position is visibly improved, as the wedges have created just the right amount of adduction needed to encourage his lower limbs back into midline. Customising the tapered wedges appeared to have worked effectively to correct David's lower leg position, as seen in Figure 8, and also improved his shoulder alignment.
