CLINICAL CASE

ERIN DAVIS (NZROT), OCCUPATIONAL THERAPIST,
SOUTHERN REHAB, NEW ZEALAND

Enhancing positioning and maintaining skin integrity, by using Vicair cushions

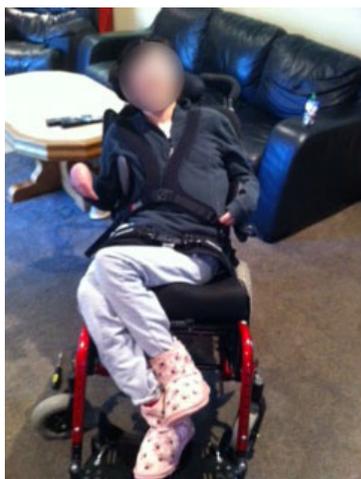
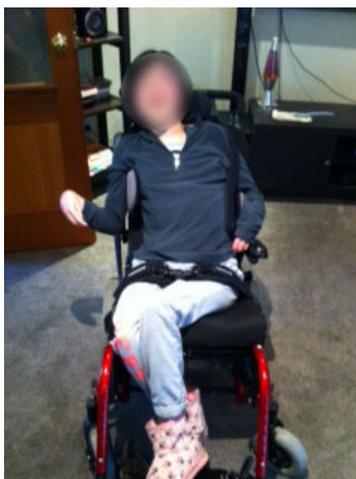
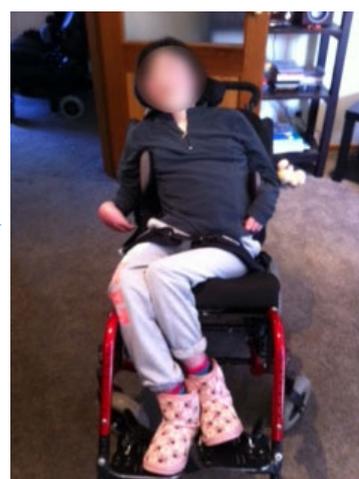
Cycle of adjustment of the seating system pre-Vicair

This seating system needed to be reviewed and adjusted every 6 to 12 months and prior to starting the clinical trial it was found that it wasn't supporting her accurately. Limited further contouring was achieved but she was starting to get reddening of her skin over her left ischial tuberosity.

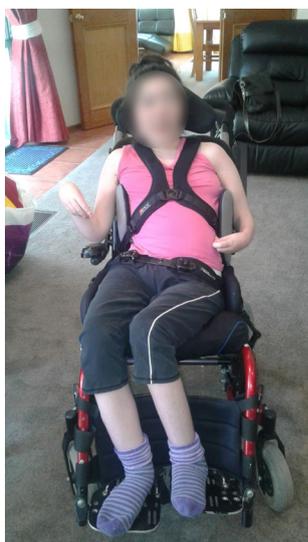
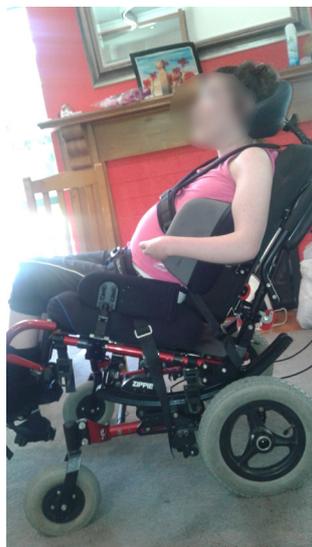
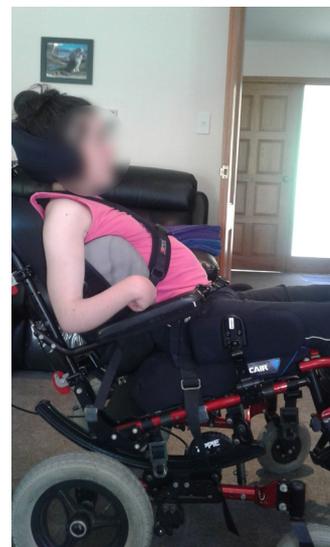
The Vicair Multifunctional back support cushion was also trialed, replacing the foam contouring on the existing back shell. It was set up with an increase in cells in the lower three compartments. It was found that Miss Y now had contact with her entire trunk and therefore gained the support in the lumbar region that she required.

Instead of sitting on top of her seating and being pushed forward, Miss Y is immersed into it. Rather than sitting on top of her cushion she is now sitting in it, therefore cradling her dislocated hips and filling all the gaps at her spine to give improved support.
